Chapel Hill Winery: Kangarilla Vineyard creek line revegetation

Rachel Steer (and Ian Janssan) has been working on a creek line restoration project at the Kangarilla Vineyard over the last few years. A previous case study was included in the 'Enhancing Biodiversity in Vineyards' workshop notes and an update is presented here.

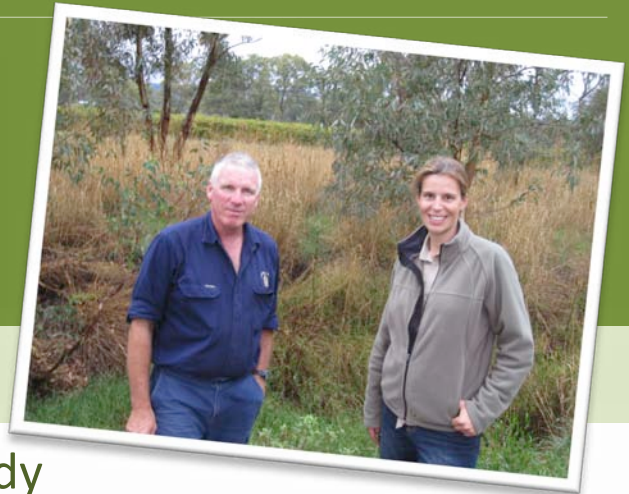
Future: Each winter/spring between 600 and 1000 local indigenous plants are planted along the creek line in allocated zones. Rainfall during the last three years has been quite variable and the dry summer of 2008/09 caused a higher mortality rate than we were anticipating. The 2009, 2010 and 2011 plantings however have all done extremely well and are becoming a visual part of the landscape along the creek (**photo left**).

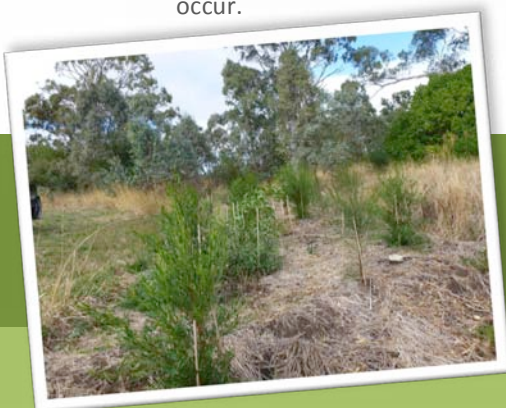
The watsonia control has been very successful with little regrowth in following years. The ash control has also been successful but there has been some regrowth from the cut stumps (**photo below**), which is proving very difficult to control. Hundreds of new saplings are being produced from seed that needs to be pulled when the creek line is damp or sprayed with Roundup Biactive. The phalaris is extremely dense and competitive and has also been difficult to control. Phalaris must be whipper snipped and allowed to regrow before spraying with Roundup Biactive.
